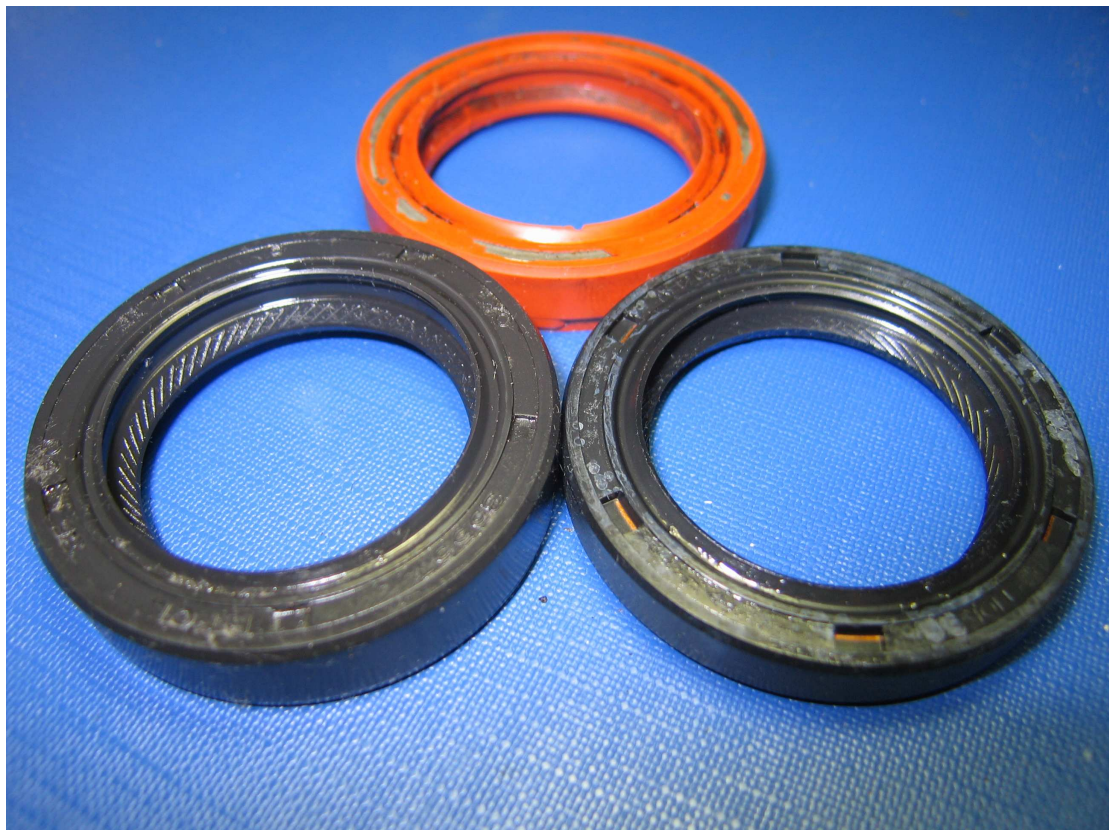
This short article is another in the “how small things can muck up your whole day” series. Referring to the photo, you will see 3 oil seals. One is 40 years old and just removed from the timing cover of a 40 year old car; not bad service considering! The one on the left is or I should say was the first replacement seal, which leaked worse than the old one – bugger! The one on the right (now installed) fixed the problem. During this process I learned a lot about oil seals; which I am happy to pass on here.

Basically, oil seals that operate on a revolving shaft, particularly high revving shafts, and contain oil in a stressed and pressured environment; are uni-directional. The seal needs to suit the shaft’s rotation. The seal on the left in the photo is (mistakenly) to suit an anti-clockwise rotation. The one on the right is for clockwise rotation. If you look closely at the photo, you will see tell tail ridges or lines on both new seals. You will note that the ridges are in opposite direction, to suit the different rotation. While I haven’t mentioned the “motorcycle” word in this article, I think you will agree that there is good general information here, applicable to any oil seal on a revolving shaft. Added to this, is that the seal you are changing may need to withstand heat, mineral or synthetic oils and varying pressures etc, hence the (specialized) material used in it’s manufacture.

Make sure you are using the correct seal to suit its application. I suggest when buying a new seal, you specify what and where within the vehicle, it is intended. I was very impressed with both bearing companies I spoke to, who were able to call up information on the computer, regarding my 40 year old Renault! I think my Renault parts man made a simple mistake in supplying a seal of wrong rotation, because of my incomplete info, or I was talking too much at the time etc, etc.
